A Geographical Information System
(GIS) Based Evaluation of Landslide
Susceptibility Mapped on the Harrison
Mountain Quadrangle of the Santa Ana
River Watershed

Crystal Moncada

California State University San Bernardino

January- July 2014

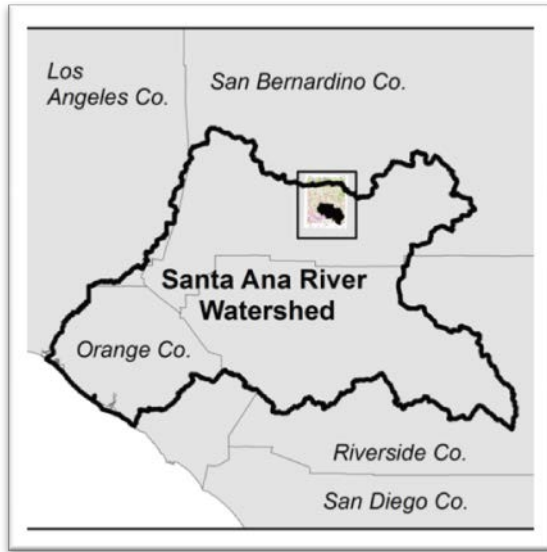
Figure 1. Locator Map.

The study area is located in the Harrison Mt. 7.5 min USGS quadrangle which encompasses the southern portion of the San Bernardino Mts. in the eastern Transverse range, southern California. This cismontane region is encompassed by the Santa Ana river watershed which covers 6,863 km² (Figure 1). The area of mapping was defined by Google Earth™ aerial imagery coverage taken on 9 March 2011 after the December 2010 rain event. This available true color photography spans from the San Bernardino Valley at the city of Highland to the summits of Harrison Mt. and Mt. McKinley. Elevation ranges from 448 m to 1,445 m (Figure 2), where precipitation was rainfall in the storm. The climate of this region is characterized as a Mediterranean type, with cool wet winters, warm dry summers, and mean annual rainfall of 43 cm (17 in) registered at the nearby City Creek weather station. Orographic lift results in increased precipitation up the mountain slopes compared to the valley. The study area vegetation is predominately shrubland of sage scrub and chaparral which burned in the “Old Fire” of October 2003. Regenerating vegetation successions in shrublands include abundant cover of non-native invasive annual grasses (e.g., *Bromus diandrus*).

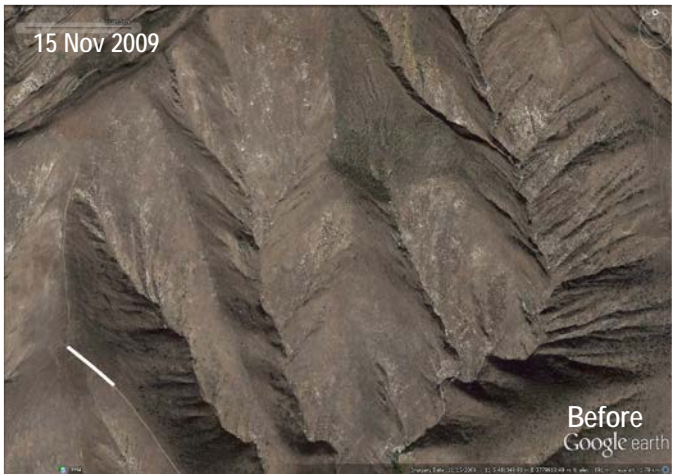
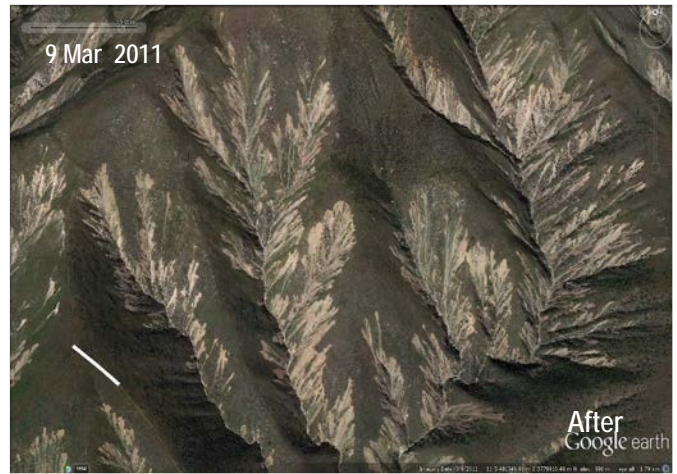
Figure 3. Aerial images of Harrison Mt. before and after storm. White scale bar= 100 m.

Erosion scars of landslides were mapped using Google Earth™ imagery taken 15 Nov 2009, and 9 Mar 2011 (Figure 3); the before and after comparison between the two images made it possible to outline every landslide which occurred after the storm. The “add polygon” tool of Google Earth™ was used to delineate polygon perimeters directly on imagery at boundaries where light tone and rough texture of erosion scars sharply contrasted with surrounding vegetation. Eye altitude of 2,000 m above the land surface was used for consistent scale as well as elevation altitude between 1,000 to 3,000 ft. Historical imagery timeline was used to check images before and after December 2010 to confirm landslides resulted from the storm. Delineated polygons were saved as KML files, and imported into ArcMap 10.1 as shapefiles for GIS analysis with a 10 m resolution DEM from the USGS, and a pre-fire vegetation map produced in 1997 for the California Forest Resource Assessment Project (FRAP- CalFire). Shapefiles for the Santa Ana River Watershed were obtained from SAWPA to make the locator map.
