USDA Trails Strategy

WRI: ENGLISH PEAK SURVEY

Theodore Mendoza

Klamath National Forest

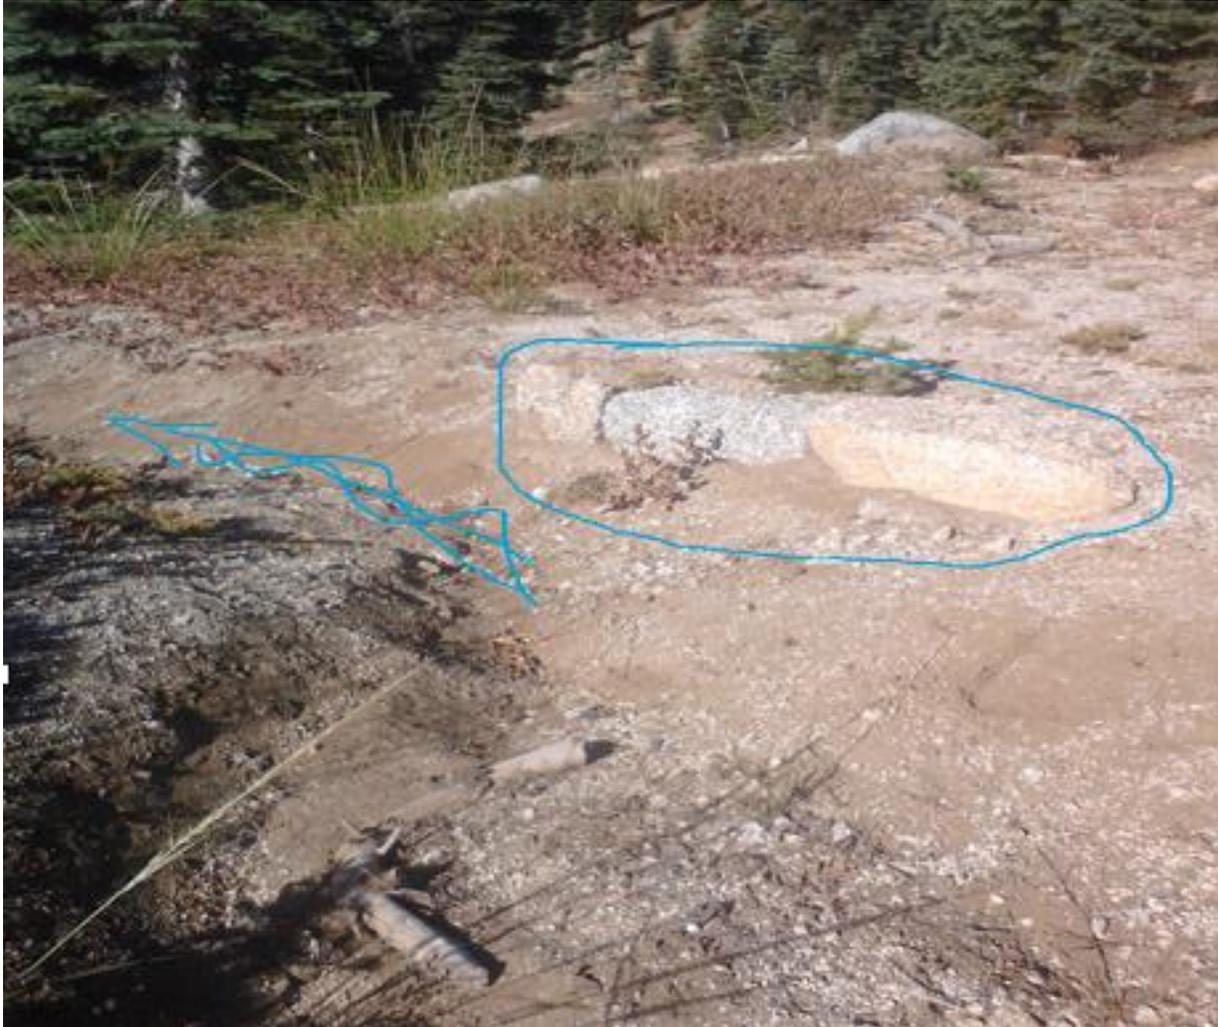
Picture 1: Water Bar on decommissioned trail causing large runnel

The data gathered would lead one to conclude that the snow melt and non-compacted soil are the main culprits for the large amount of erosion. My partner and I also discovered that an old trail running above and parallel to the current one had a few water bars that became starting points of some of the deepest runnels. Prior attempts were made by putting check dams above and below the trail to slow down the flow of water. We found that these attempts unfortunately did not succeed. Although the check dams may have temporarily improved conditions, they may now actually be speeding up the flow of water through small waterfalls causing more speed and faster erosion. My partner and I marked close to 50 way points with pictures and descriptions of each. We also tracked close to 8 large runnels from their starting points atop the ridge to their ending points. The ending points seemed to gather at another meadow we discovered that had formed below the trail. For now, this meadow seems to be slowing down the watershed flow and no degradation can currently be seen.

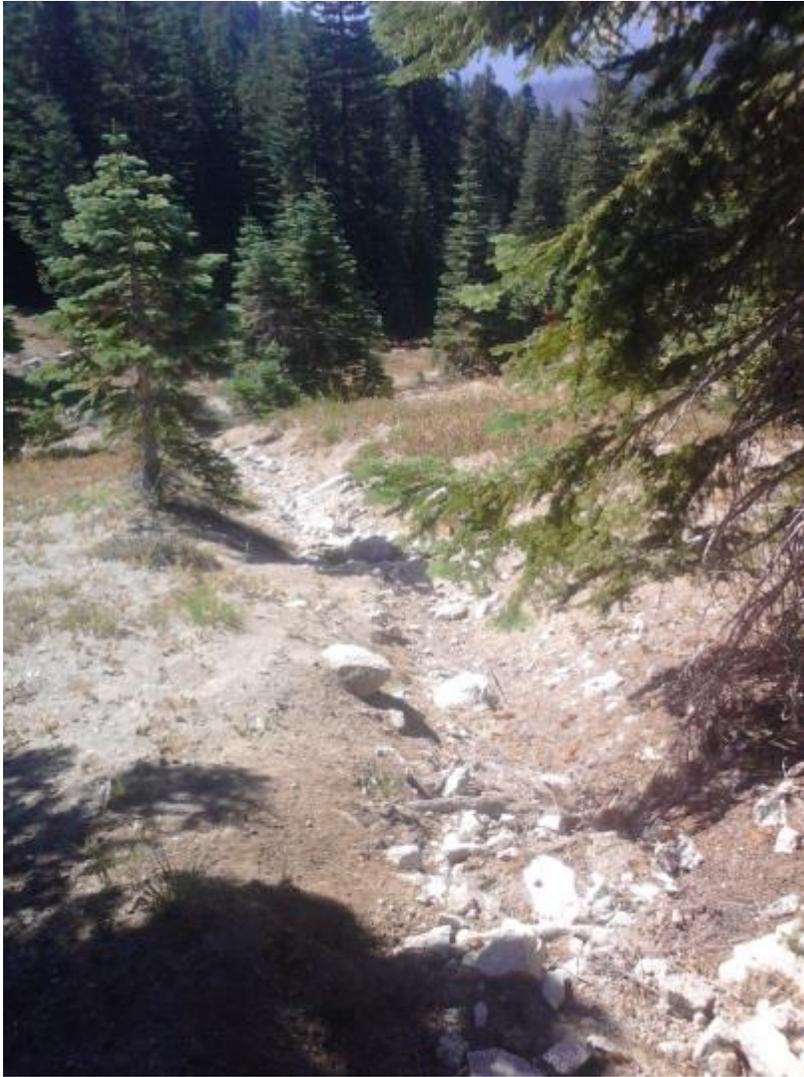
Picture 2: Large runnel and failed check dams

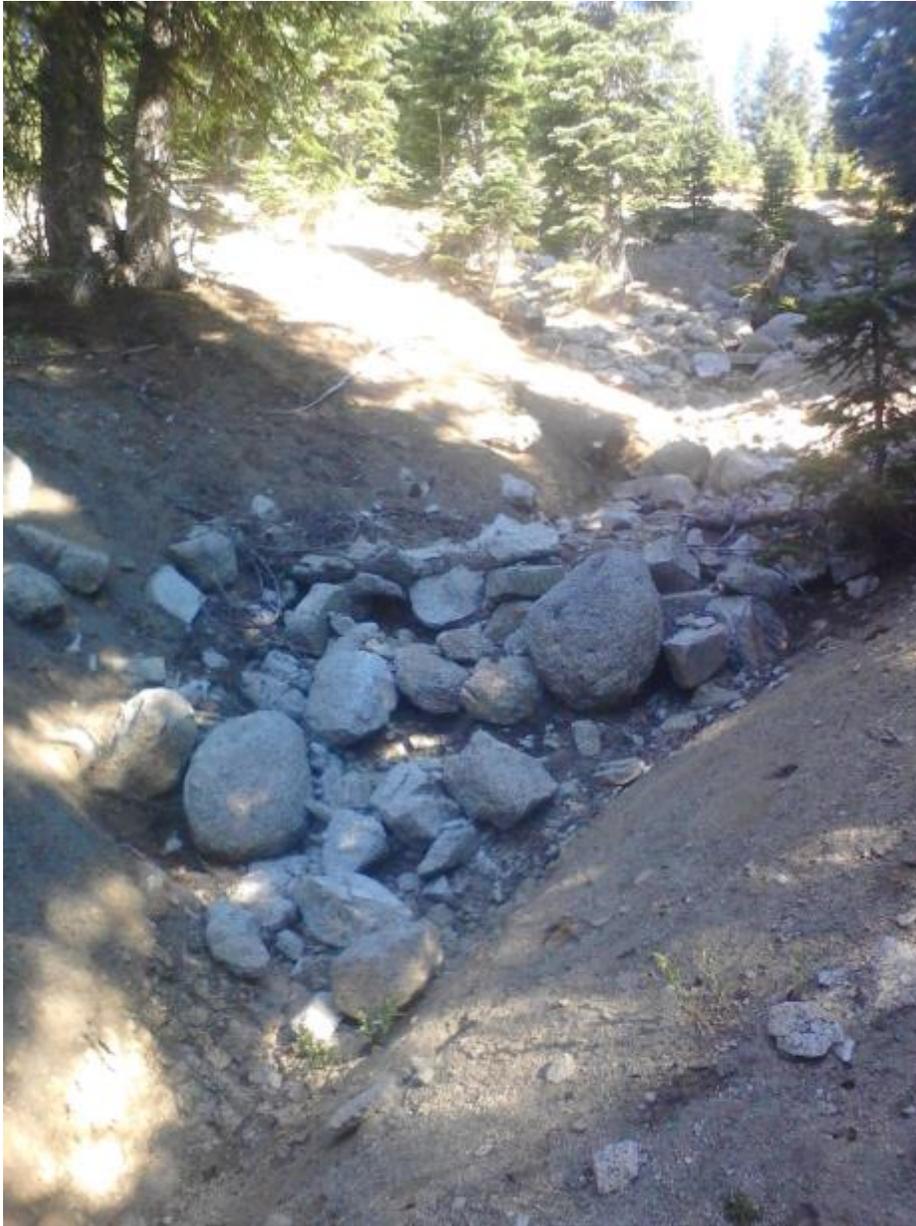
Picture 3: Wide runnel with large sediment loss

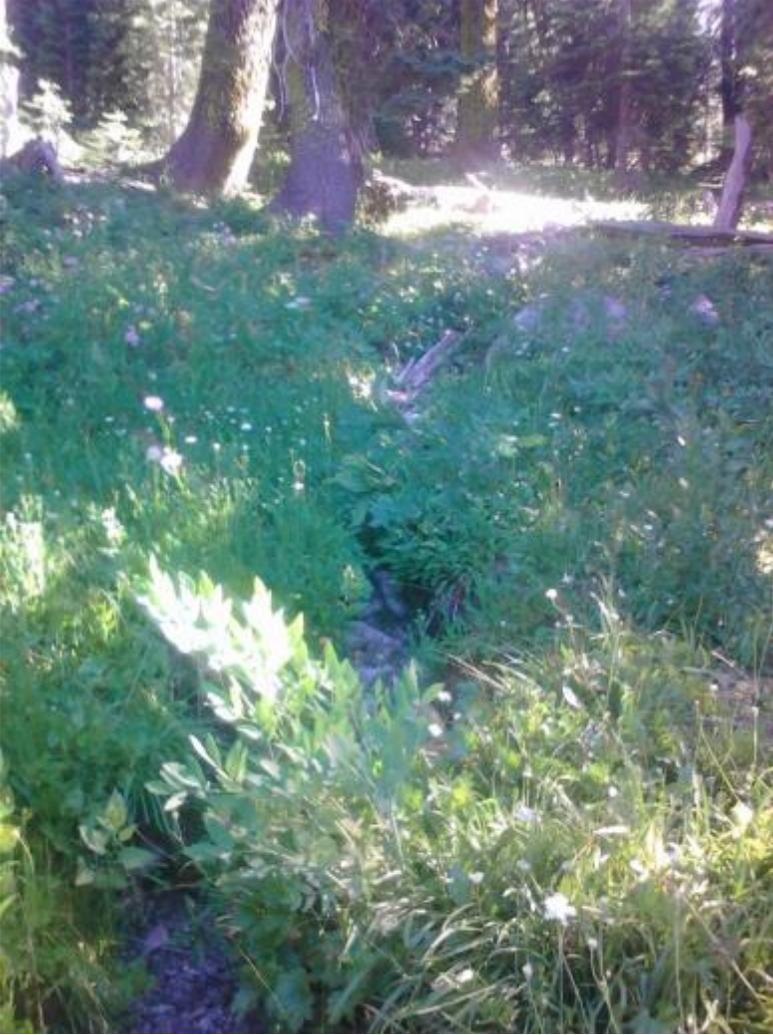
Picture 4: Second meadow gathering water from bowl

If one were to continue the project, further research should be done below the second meadow. One would need to similarly survey the area in order to see if similar damage is being done further down the mountain, or if the meadow is completely slowing down the flow of water. My personal recommendation would be to study and maintain the second meadow in order to not have a domino effect causing runnels down the next section of the mountain face. The plant species thriving in the second meadow as well as other nearby meadows would also be good information to have. If resources and time permits, a restoration project could put into place by planting the successful species in the eroding meadow. The successful species could potentially absorb more water and keep the soil intact. Old water bars and check dams that have proven unsuccessful should also be removed. Finally, research should be done on thriving meadows in the area in order to analyze the factors that contribute to their success.

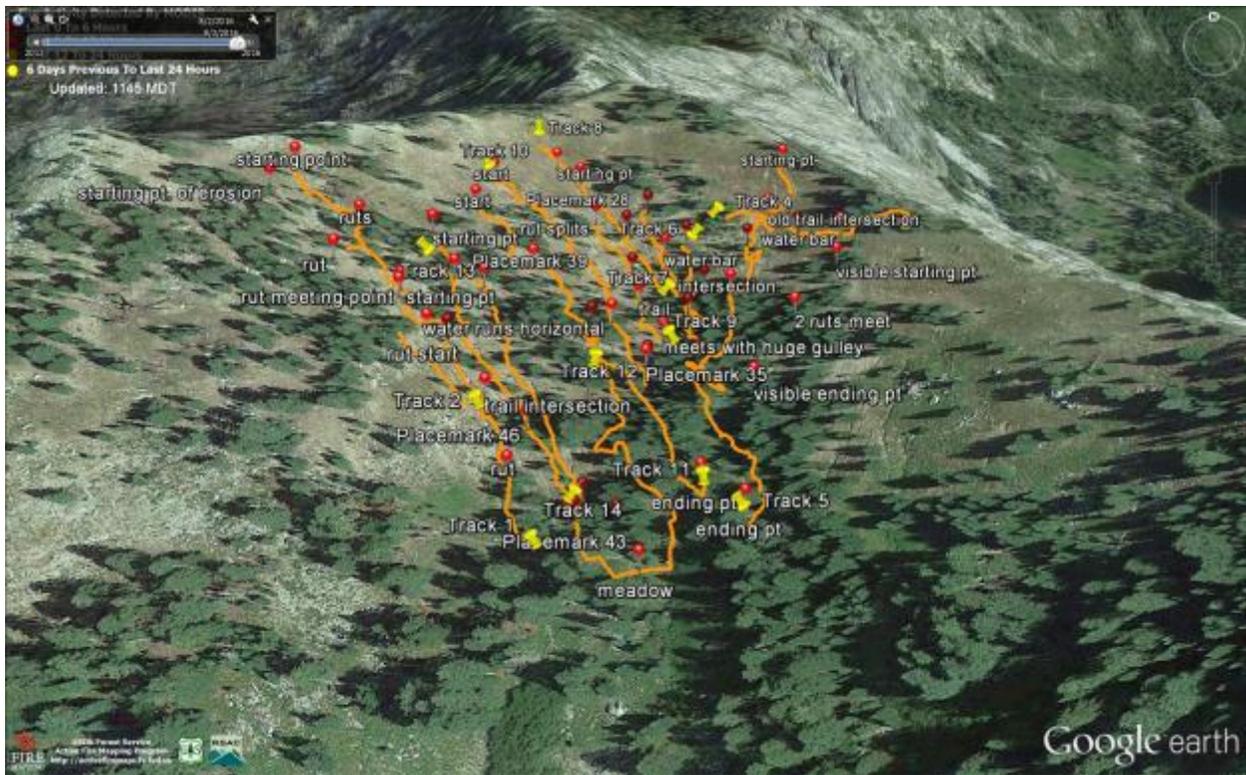
Picture 5: Google Earth data gathered at site

The waypoints, tracks, pictures, and recommendations were uploaded to google earth in order to organize the data. This data is now available to other people working for the forest service who are interested in the project. They will now be able to see the problems and potential solutions online without having to physically hike the trail. This data will also be used with GIS and will be the start to a new form of trail inventories for the forest service.
